# Compatibility between Canals Lining Methods and Sites Conditions

## Case Study: Al-Khofoog Canal, El-Minia

Tarek Sayed Abu-zeid

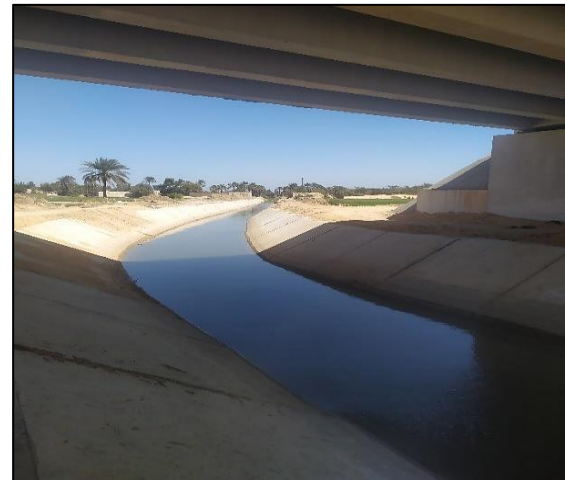
Al-Khofoog canal belongs to west El-Minia Irrigation Engineering Administration in El Minia, Egypt. It takes its share of water on the left bank of Manshyat Al-Dahab canal at km 46.180 and its length is about 6.730 km as shown in figure (1). It serves an area of about 6000 feddans. The proposed length of the rehabilitation and lining process is 3.250 km, starting from the Km 0.0, and rehabilitation works were carried out for a length of 560 meters only, starting from the Km 1.600 by using rubble stone with a thickness of about 50 cm, topped by a layer of plain concrete with a thickness of about 12 cm with side slopes of 3:2 as shown in figure (2), and with the necessary construction joints as shown in photo (1). Photo (2) shows the canal before lining.

Photo (1): Lining works in the canal

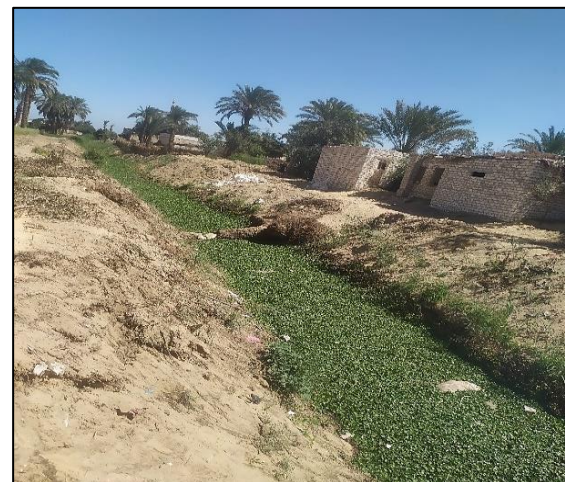
Photo (2): Unlined canal section

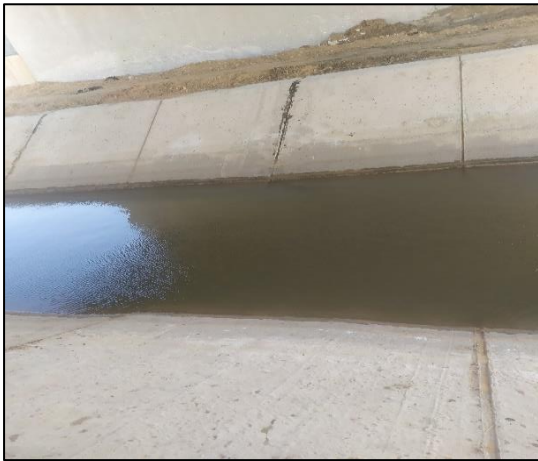
It was observed that there was seepage of water into the canal cross-section at a height of about 1.00 m above the bed level and sometimes it may reach about 1.50 m, which causes great impediment during the implementation of the lining works, and the usage of large quantities of stone to be able to implement a regular concrete lining with the required thickness. To find out the source of this accumulated water, the gates of the intake of the canal were checked if they were

open or not, or if there was a leakage permits the water to flow into the canal. It was observed that these gates were totally closed and that there was no leakage of water into the canal. By the topographical nature observation of the canal site with respect to the surrounding agricultural lands, it was found that the canal is in the lowest area in the region, which makes it a drain for those lands. It is worth mentioning that the water table in west El-Minia is very high, reaching in some places and sometimes the land surface. Accordingly, the cause of these amounts of water can be referred to that, in addition to the seepage of drainage water from the agricultural lands, which may affect the safety of the lining works. The following photos (3) and (4) show those amounts of seepage water in the canal section, and the surrounding agricultural lands.

Photo (3): Water seepage into the canal

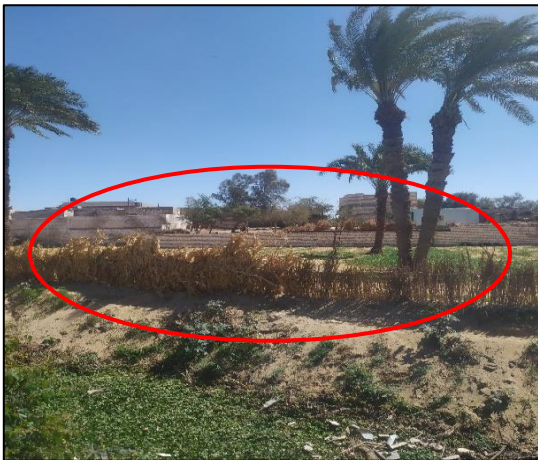
Photo (4): Buildings and lands near the canal

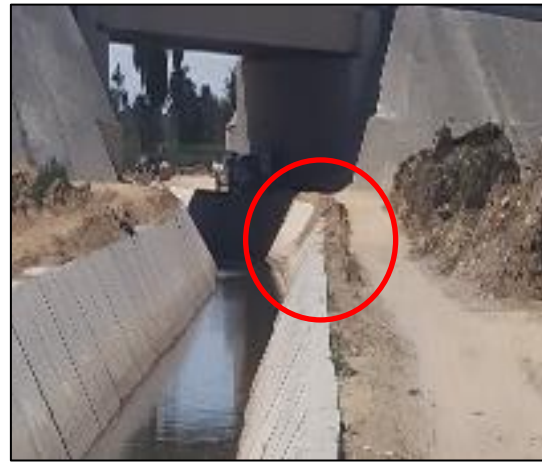
There were some failures in the bed slabs due to the large amounts of seepage water into the canal cross-section. It was also noticed that there was sliding and failure in some of the side-lined slabs, as well as some failures of the canal slopes in places that have not been lined, as shown in photos (5) and (6).

Photo (5): Sliding in some lined slabs

- The large amounts of seepage water from the surrounding high lands into Al-Khafoog canal cross sections causes many failures and sliding of the implemented parts of the proposed lining type (50 cm. rubble covered with 12 cm. plain concrete), for these reasons, this type of lining is refused.

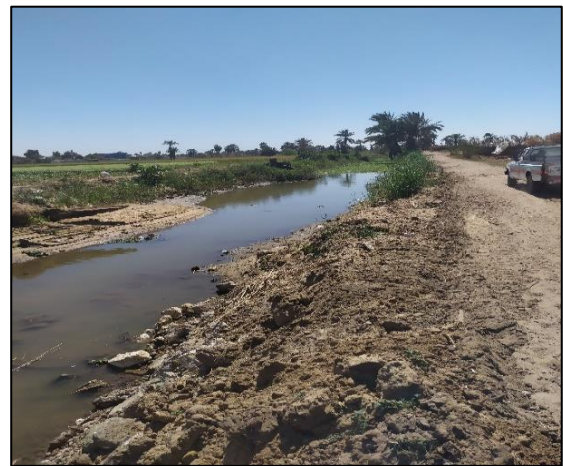
Photo (6): Failure of canal side slopes

The soil, according to the samples taken from the site, is very fine soil with a small internal failure angle, so a slope of 3:2 may be not suitable with its nature and it would be better if the side slopes in such soils were 2:1 to ensure more stability of slopes and avoid such failures.

- Proposed internal side slopes of Al-Khafoog canal cross-section under implementation (3:2) is unsuitable for the existing type of soil in the field and must be changed to be (2:1) which is more suitable and compatible with the soil type for more stability of slopes.
